10-YEAR PAINT TESTS ON WEATHERED GALVANIZED ROOFING

By A. J. Muehling and J. O. Curtis

UNIVERSITY OF ILLINOIS
AGRICULTURAL EXPERIMENT STATION

August, 1961

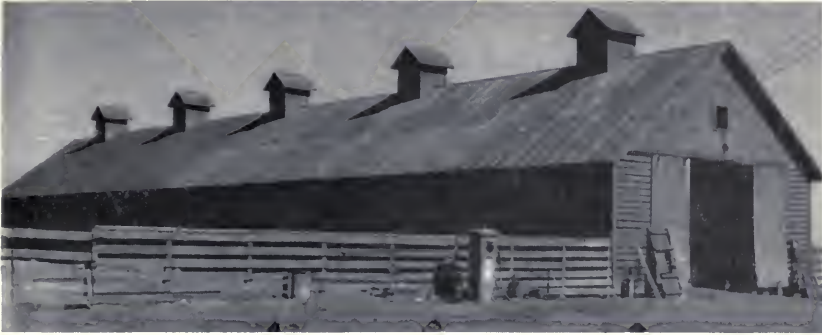
North side of crib before painting. The one-third of the roof at the left (Panels 46 through 81) was 100 percent rusty. (Fig. 2)

The panels on the northern exposure for the second replication were 100 percent rusty when they were painted, and the average film failure at the end of 10 years was 28.4 percent. The panels for the first replication on the northern exposure varied from 50 to 90 percent rusty, with an average of 65 percent rusty, and the average film failure

at the end of 10 years was only 7.8 percent. The difference between these two averages indicates that the original condition of the panels had a definite effect on the performance of the paint systems.

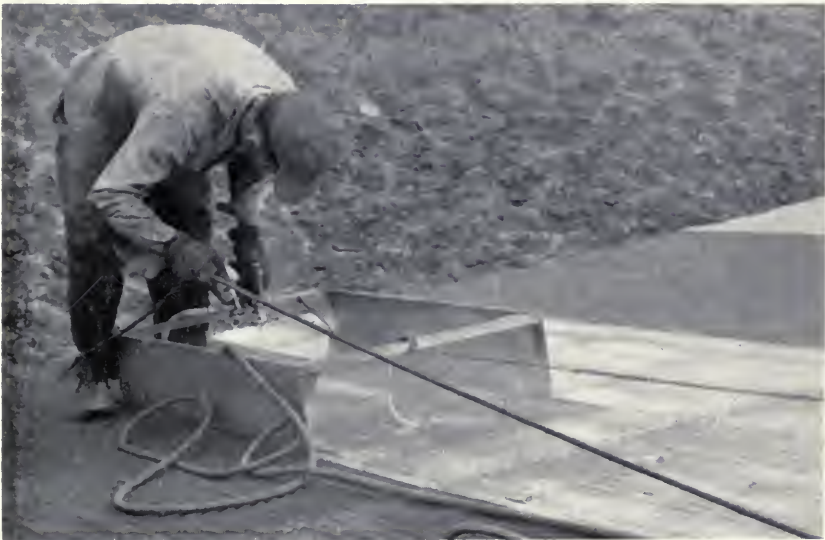
An aluminum shield was used to prevent spray from blowing to adjacent panels. (Fig. 3)

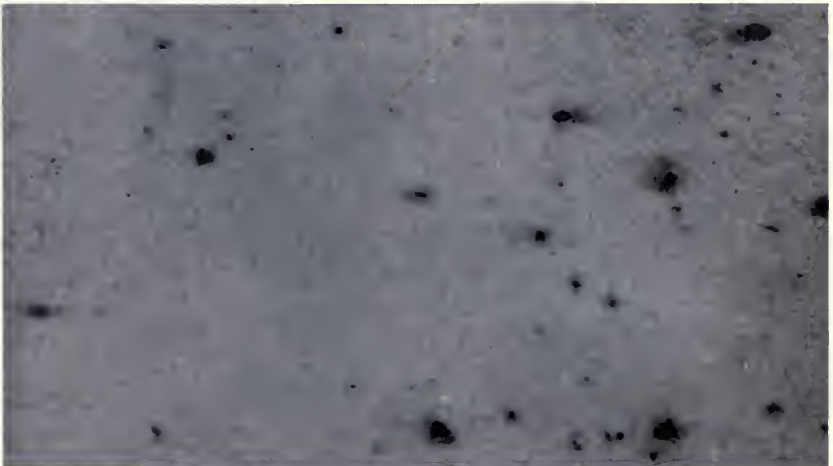
Photographic reference standard Number 8 — type 1, rusting not accompanied by blistering. This standard has often been recommended as the "repaint stage." Photo courtesy American Society for Testing Materials. (See literature citation 12.) (Fig. 4)

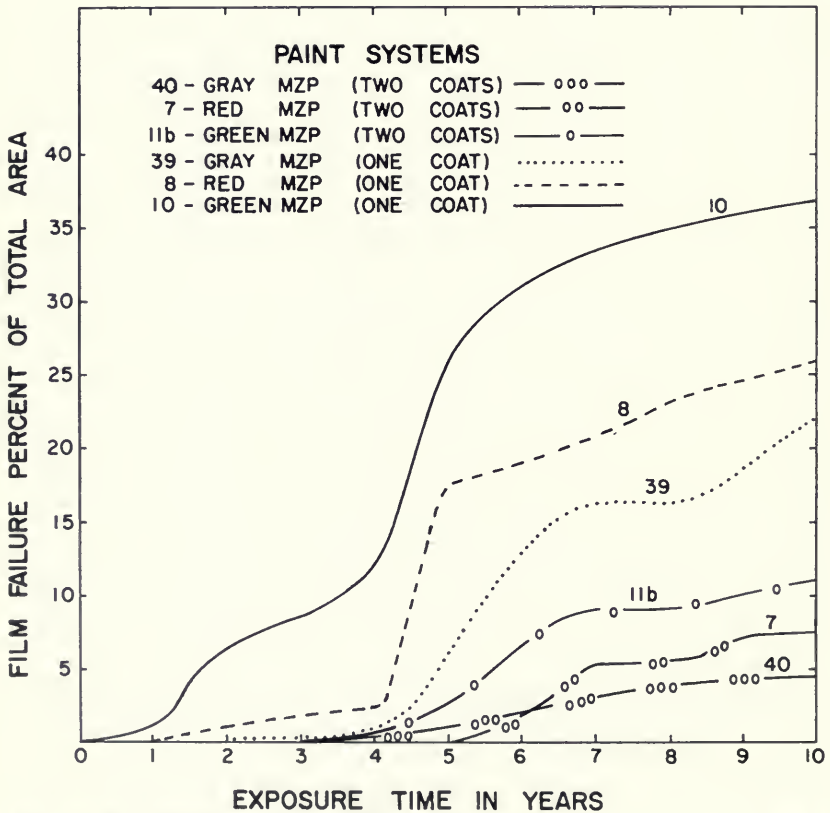
(Fig. 5)

Performance of metallic zinc paints.

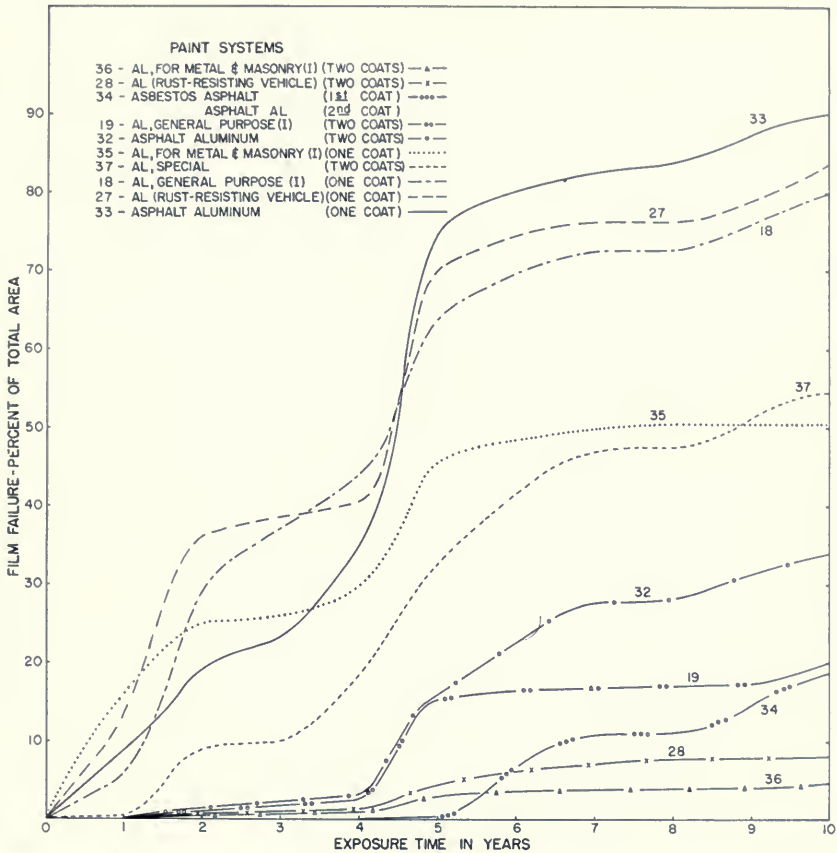
(Fig. 6)

Performance of aluminum paints.

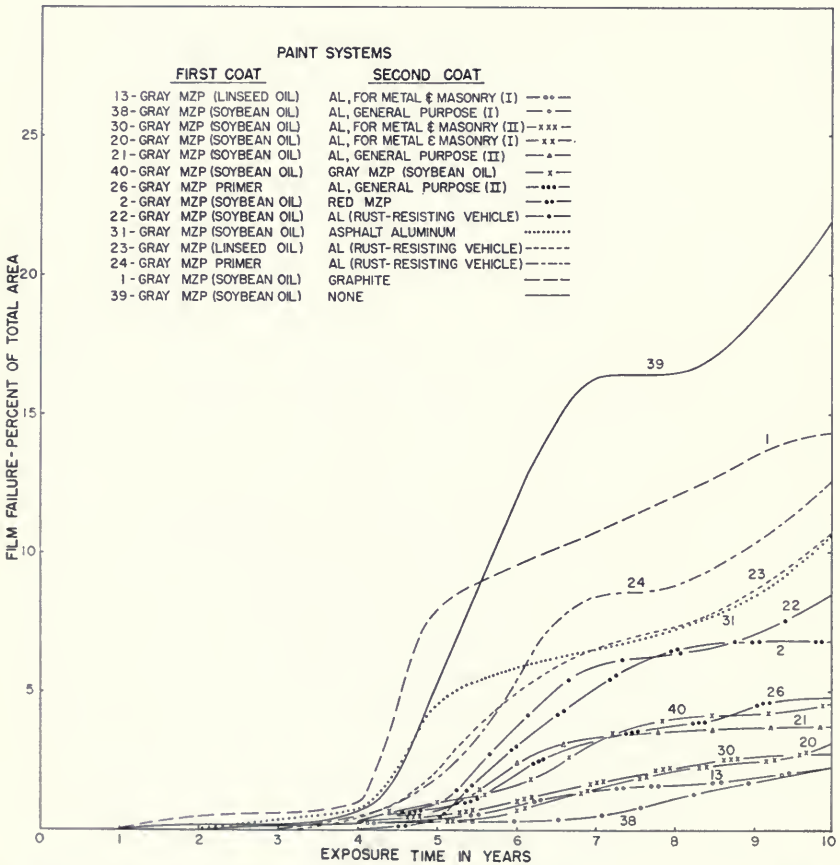
(Fig. 7)

Performance of paint systems with gray MZP for a first coat.

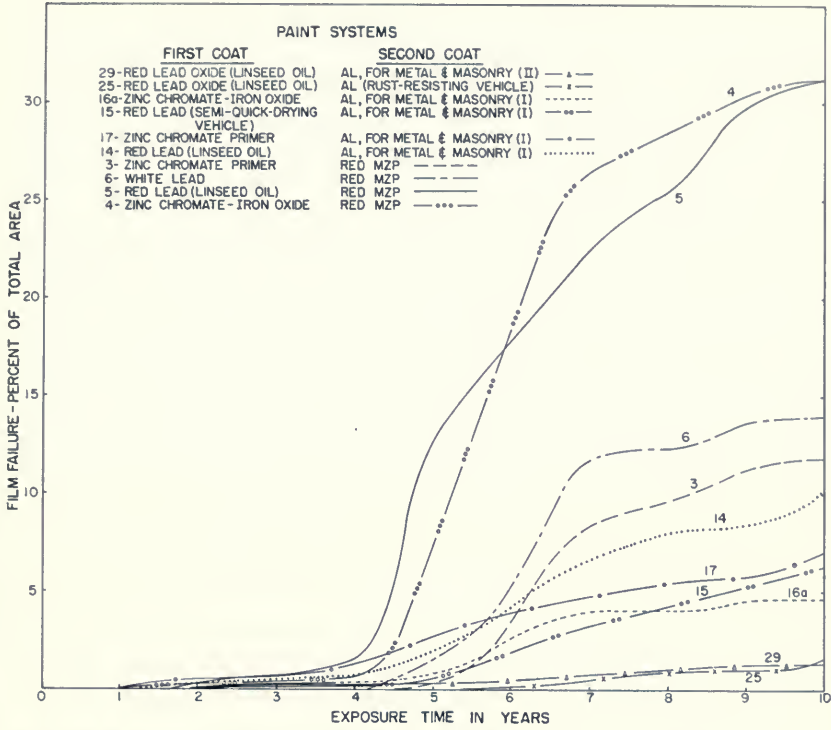
Performance of paint systems with red lead, white lead, or zinc chromate for a first coat. (Fig. 8)

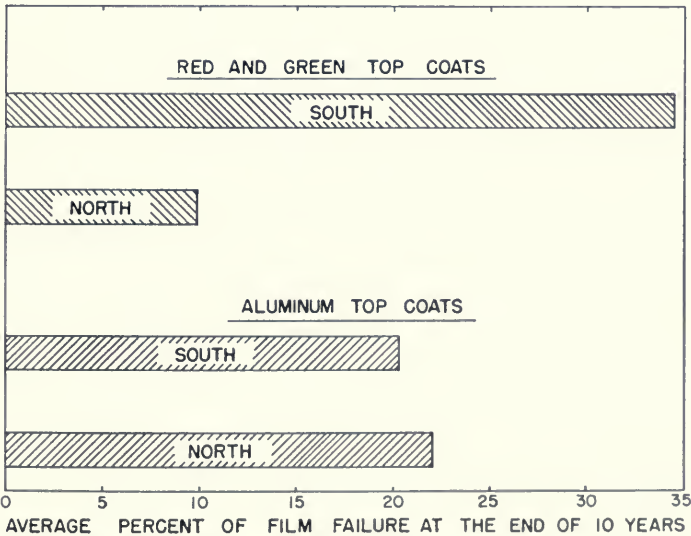
In every case, the film failures from the paint systems with a red or green top coat were larger for the southern exposure than for the northern exposure. The exposure did not seem to affect the performance of the paint systems that had a second coat of one of the aluminum paints. Fig. 9 shows the contrast between the two groups of paints. The average film failures at 10 years were almost equal (20.3 compared with 22.0) for the northern and southern exposures of the paint systems

Effect of exposure on red and green top coats and aluminum top coats (Fig. 9)

1. Exposure had a definite effect on the paint systems with a red or green top coat, but no apparent effect on the paint systems with an aluminum top coat. All panels with a paint system composed of a red or green top coat had an appreciably larger film failure on the southern exposure than on the northern exposure. There was no significant difference between film failures on the northern and southern exposures for the aluminum top coats, or for the gray MZP top coat.

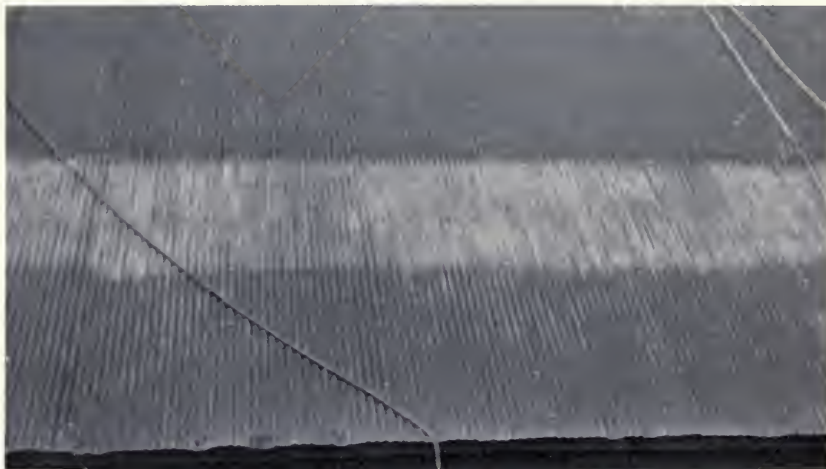
spection, panels 46 through 81 were studied with special care to see if any difference existed between the paint performance of the sections that had been wire brushed and the remaining portions of the panels. As far as could be determined, the wire brushing had no effect on the ability of the paint to withstand weathering.

The top portions of the bottom sheets of Panels 46 through 81 on the north side were wire brushed before painting. These panels were 100 percent rusty (see Fig. 2). (Fig. 10)
